PREFLIGHT

APRIL, 2017

Huey 823 Restoration Progress

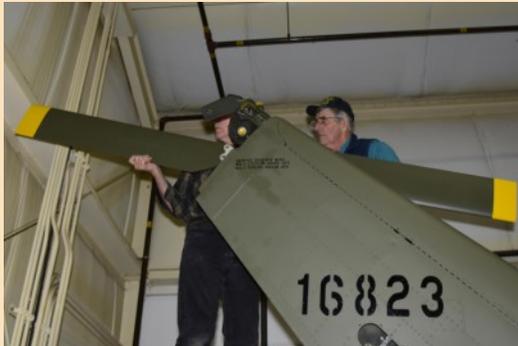
Steve and Frank rigging the tail rotor controls above. The many volunteers involved in 823's restoration make it look easy when it comes to her restoration. In fact, it's quite the opposite. One of the FAA directives mentioned last month had caused the group to look for a new/used Tail Rotor Control Tube. The Army, when the UH-1H's were still in the inventory, found one that had broken. They identified one company (identified by a CAGE - Contractor and Government Entity Code) that did not follow the drawing information properly in the process of manufacturing and they

bypassed the hardness requirements. The Army pulled ALL the tubes manufactured by that CAGE, and, of course, the one on Huey 823 had that CAGE Code indelibly printed on the shaft. Searching for a serviceable control tube has proven expensive (as has everything else) but we have located one and now we can continue with the installation and rigging of the tail rotor system, and cross one more major item off the "to-do" list!

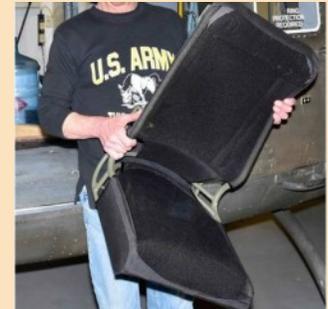
Check out the seat webbing story on this page. We had some difficulty obtaining the web material seat covers for the

pilot and co-pilot seats due to the replacement in flying Hueys with cushioned, non-armored seats. Current seat webbing manufacturers did not have a pattern for the covers we needed so we sent the contractor the old covers from 823.

By the Army TM, mesh seat covers are required to be replaced every 24 months to retain their crashworthy capability, due to weather and personal contact. LWA QC is investigating a "conditional" replacement criteria to replace the current "time" replacement criteria.

Why is seat webbing so important? Simple answer is that the aluminum frame, mesh cover and armored seat assembly all contribute to the crashworthiness of the seat. The webbing absorbs some of the g-forces, with more consumed by the aluminum frame and the shock absorption of the mounting points of the armored seat. The addition of lap and shoulder belts to keep the occupants in the seat, allows for the term 'crashworthy' to be used (meaning the occupants SHOULD survive a standard crash).
